## Notes for Guide Bush Installation

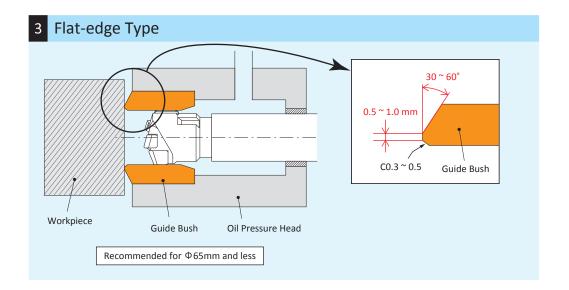
Guide Bush

Many of the problems in BTA drilling are caused by incorrect use of the guide bush. The shape, type and tolerance greatly affect cutting accuracy and tool life. Please note the following when using one in your application.

Tool Dia. D (mm)	G6 Tolerance (mm)
8.00 - 10.00	+0.005 ~ +0.014
10.01 - 18.00	+0.006 ~ +0.017
18.01 - 30.00	+0.007 ~ +0.020
30.01 - 50.00	+0.009 ~ +0.025
50.01 - 80.00	+0.010~ +0.029
80.01 - 120.00	+0.012 ~ +0.034
120.01 - 180.00	+0.014 ~ +0.039
180.01 - 245.99	+0.015 ~ +0.044
